OCALA TPO BUS STOP ADA ASSESSMENT DRAFT REPORT

June 21, 2013

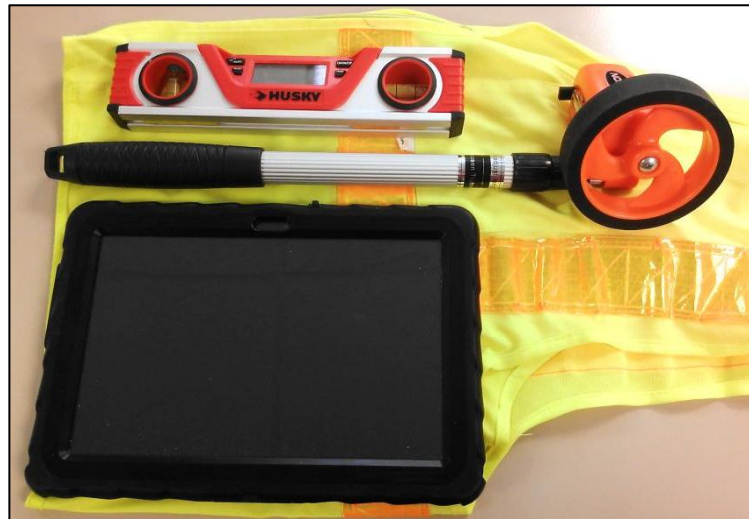
Figure 2-1 Data Collection Tools

Figure 2-1 illustrates the primary equipment utilized by the surveyor teams during the data collection process.

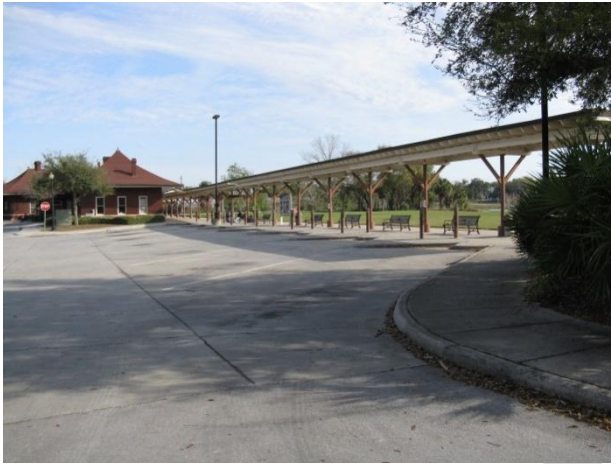
Access to the raised concrete bus loading island containing the transfer station and its amenities is unrestricted and routes to the bus boarding and alighting areas are fully accessible. Additionally, the connecting pathways from the bus boarding and alighting areas to the adjoining sidewalks, Greyhound depot, and parking areas are also compliant with minimum ADAAG and FAC regulations.

LOOKING NORTH AT BUS LOADING ISLAND

1. When necessary to replace the bus loading island concrete surface, ensure that the replaced surfaces do not exceed a 2% cross slope.

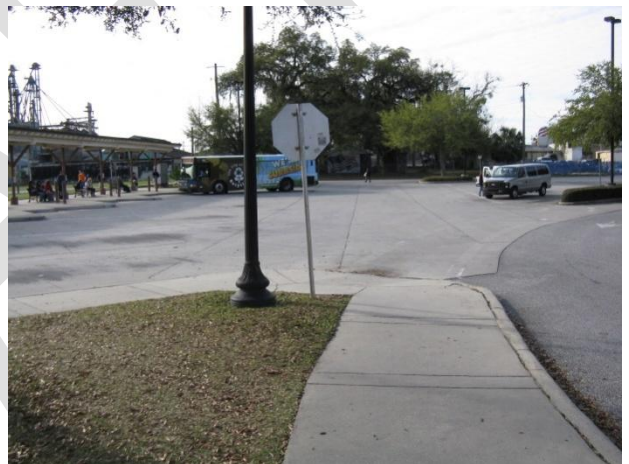
CURB RAMP TO PARKING AREAS

- 2. Replacement of the curb ramp to remedy the excessive slope is necessary.
- 3. Replacement of the curb ramp to remedy the excessive slope is necessary.

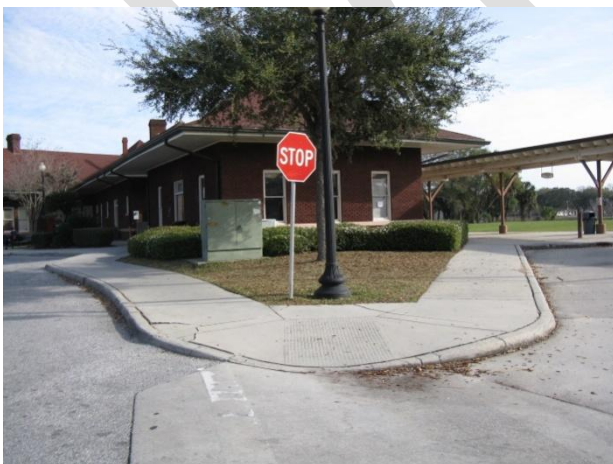
CURB RAMP TO PARKING AREAS (OPP VIEW)

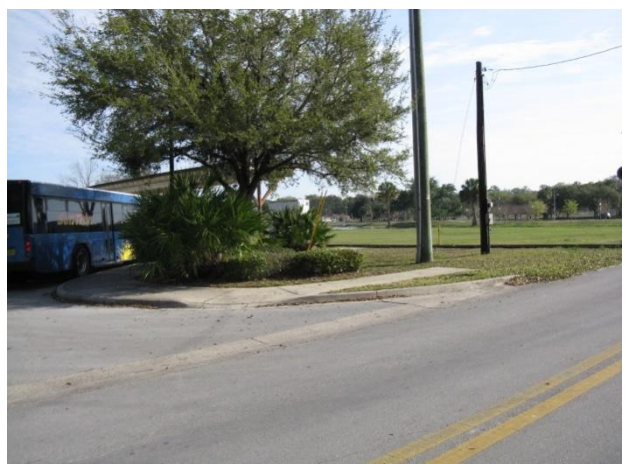
CURB RAMP FROM BUS LOADING ISLAND

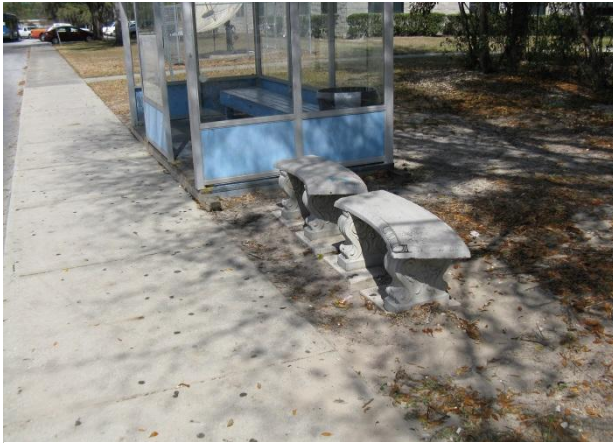
Transfers between the Blue and Red lines (#2 and #5) are provided at the stop. The bus stop presents several accessibility deficiencies. There is no 5' X 8' boarding and alighting area, the shelter is not accessible, and benches located on each side of the shelter are not accessible. Additionally, the main entrance to the facility is not accessible requiring individuals with disabilities using wheelchairs or other mobility devices to use the accessible entrance just north of the bus stop. There is no signage providing this information at the bus stop.

SHELTER PLACEMENT AND BENCHES

2. The shelter must be modified to eliminate the 4" rise in elevation to provide accessible use of the shelter.
3. The benches will have to be relocated to a surface or area making them accessible (no less than a 30" X 48" clear space that is firm, stable, and slip resistant adjacent to the front edges of the benches.)

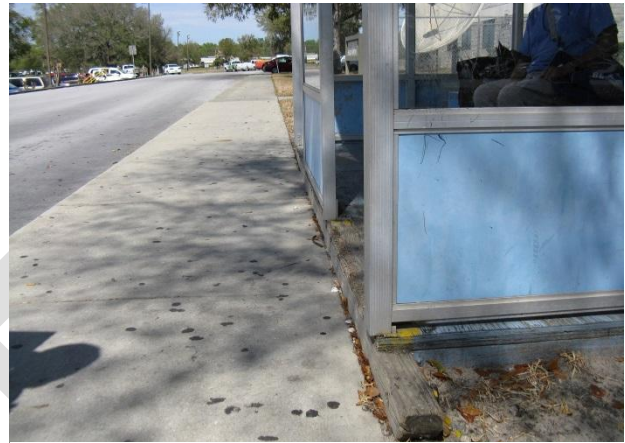
SHELTER FLOOR 4 INCHES ABOVE WALK

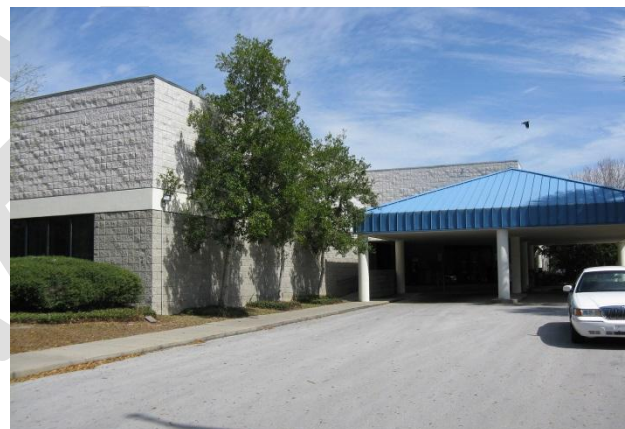
MAIN ENTRANCE (NOT ACCESSIBLE)

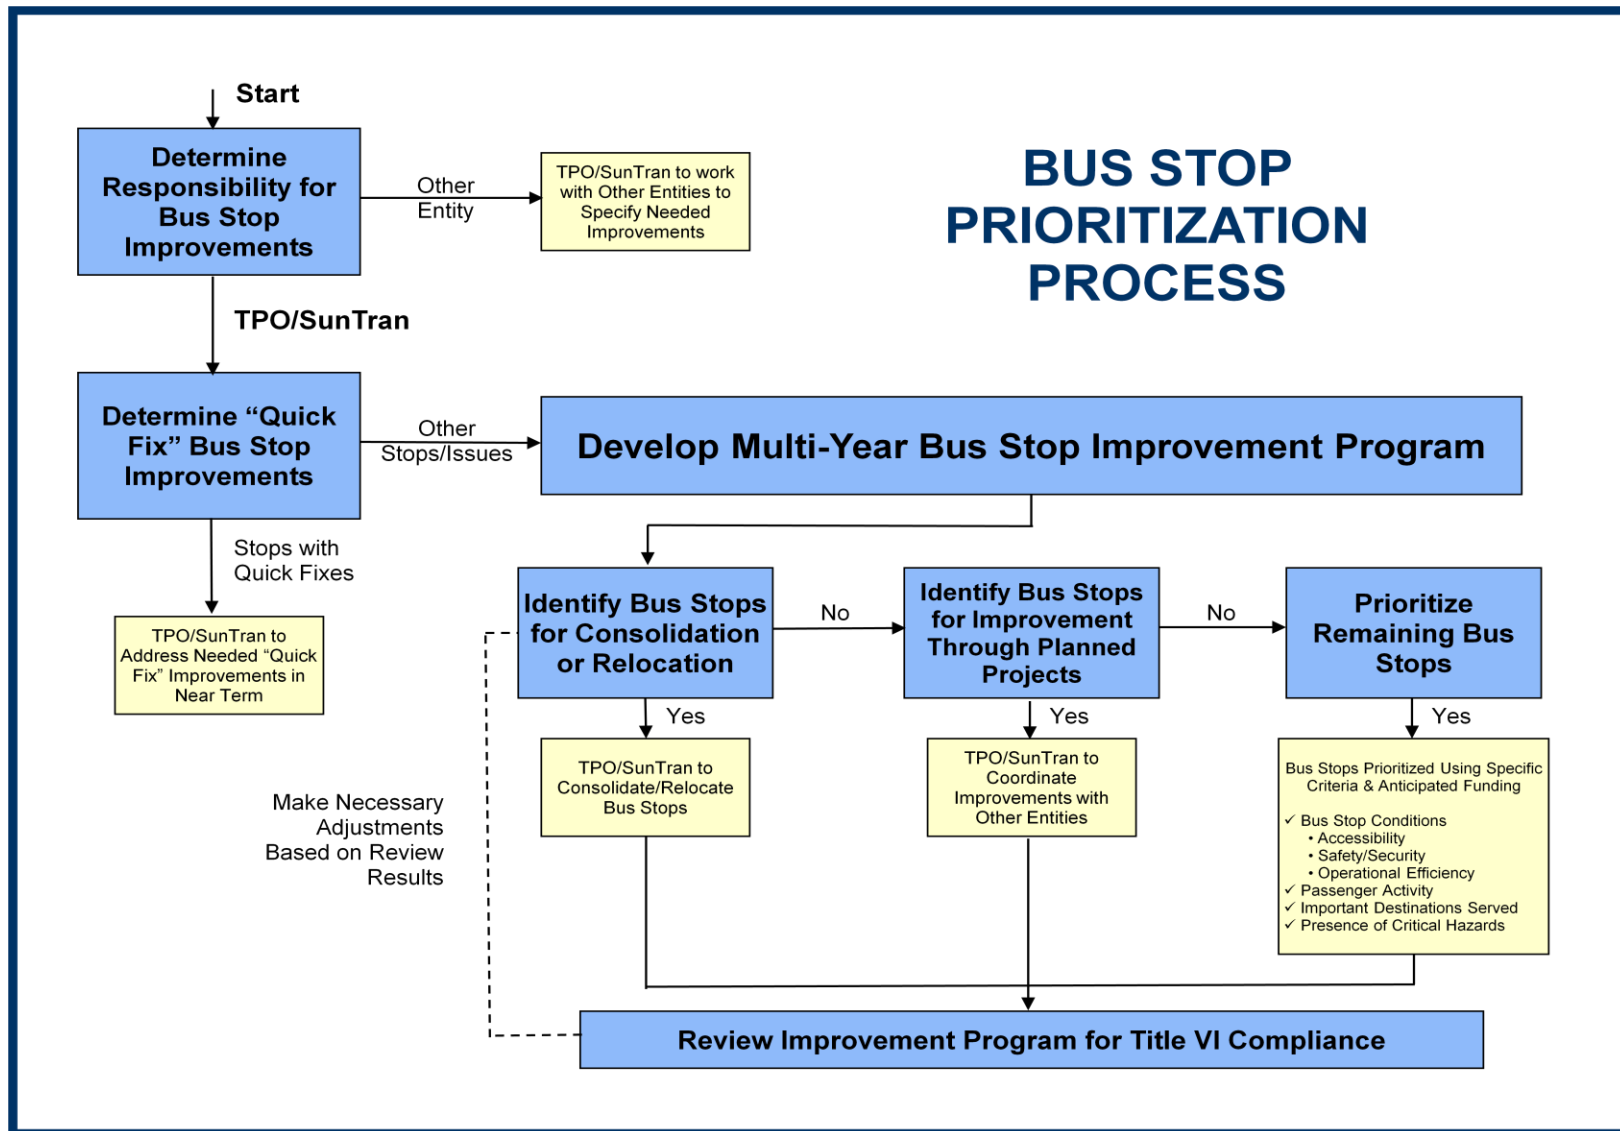
Figure 4-1 Prioritization Process Flow Chart

The first step in developing the phased implementation plan was to determine which improvements are the responsibility of the TPO/SunTran versus those improvements that are the responsibility of other entities. Although many of the identified potential bus stop improvements will need to be addressed by TPO/SunTran, it also is the case that a number of the recommended improvements may fall under the responsibility of other entities such as FDOT, Marion County, City Ocala, and/or a private entity. Based on the responsible entities identified for each type of improvement, which are presented in Table 4-1, those improvements identified to be the responsibility of an entity other than the TPO/SunTran are removed from the list of improvements that are to be included in the phased implementation plan. These improvements will be considered separately, as the TPO/SunTran will need to coordinate with these entities to specify the needed improvements and determine the best course of action to complete them in an appropriate timeframe.
